**U.S. DEPARTMENT OF THE INTERIOR  
U. S. GEOLOGICAL SURVEY**

**INTENSITY DISTRIBUTION AND ISOSEISMAL  
MAPS FOR THE NORTHRIDGE, CALIFORNIA,  
EARTHQUAKE OF JANUARY 17, 1994**

James W. Dewey (1), B. Glen Reagor (1), L. Dengler (2), K. Moley (2)

Open-File Report 95-92

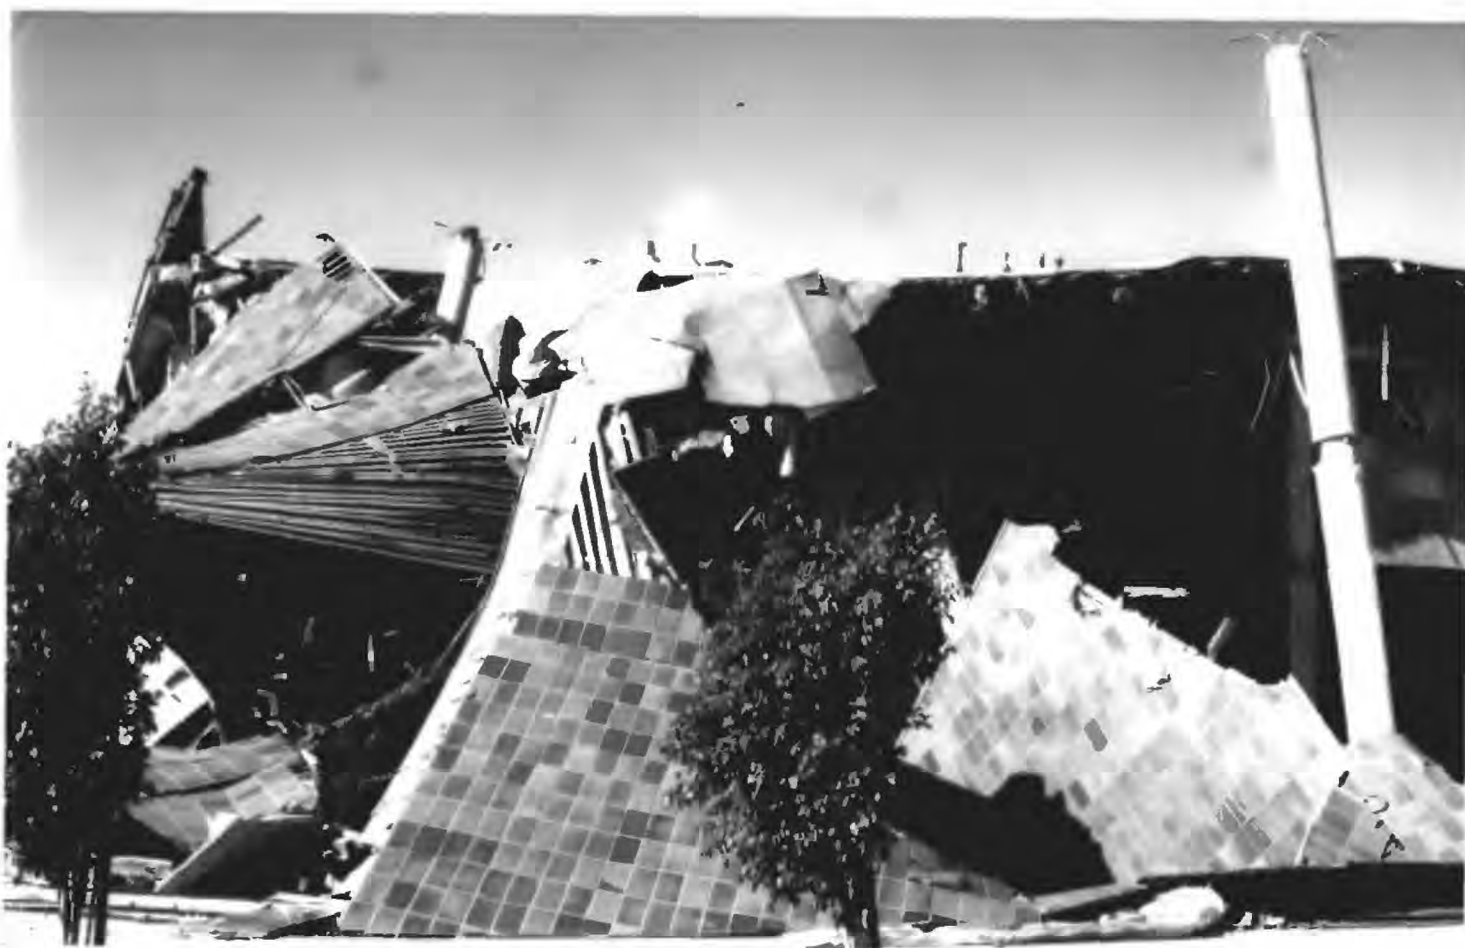
**Figure 5.** Collapsed overcrossing at the Interstate 5/California Highway 14 interchange (listed under intensity IX).

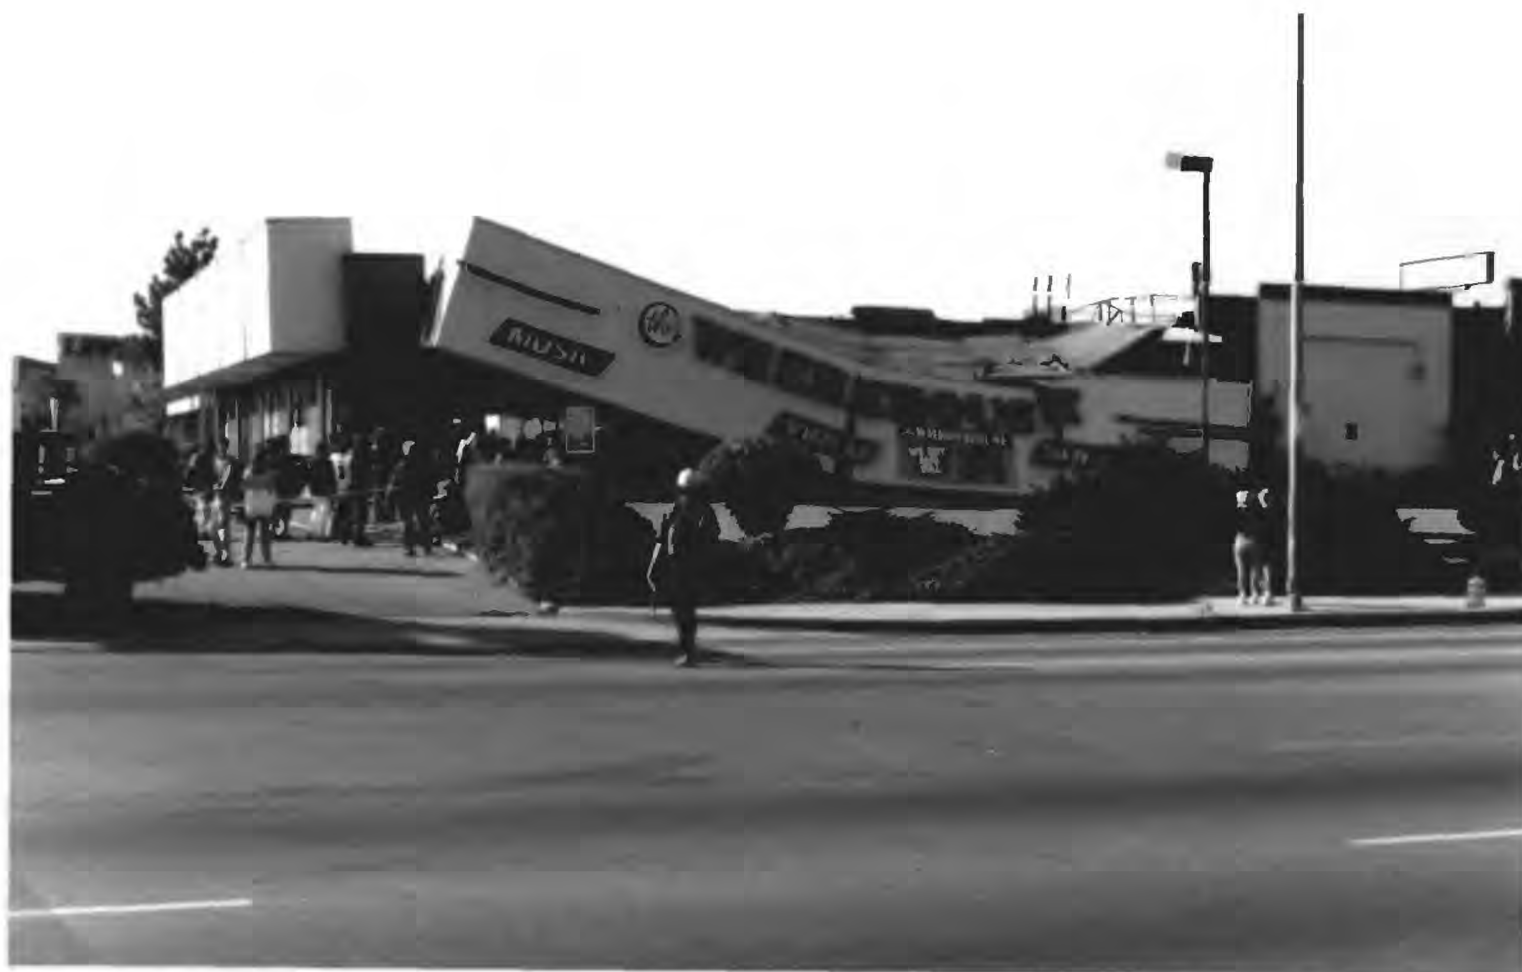
Northridge- Severe damage occurred to stores and parking structures of the Northridge Fashion Mall. Bullocks department store sustained failure at slab-to-column connections and collapsed (fig. 6) (Hall, 1994). Most of one parking structure collapsed, another had collapsed sections, and a third was severely damaged (Hall, 1994). Non-structural damage in stores of the mall was intense and would likely have caused casualties had the earthquake occurred during business hours (Hall, 1994). Satellite shopping areas near the Northridge Fashion Mall suffered extensive structural and non-structural damage, with some buildings experiencing partial collapse (fig. 7).

**Figure 6.** Collapse of Bullocks department store at the Northridge Fashion Mall, Northridge (listed under intensity IX). The notch on the standing column shows where a floor slab had been attached.

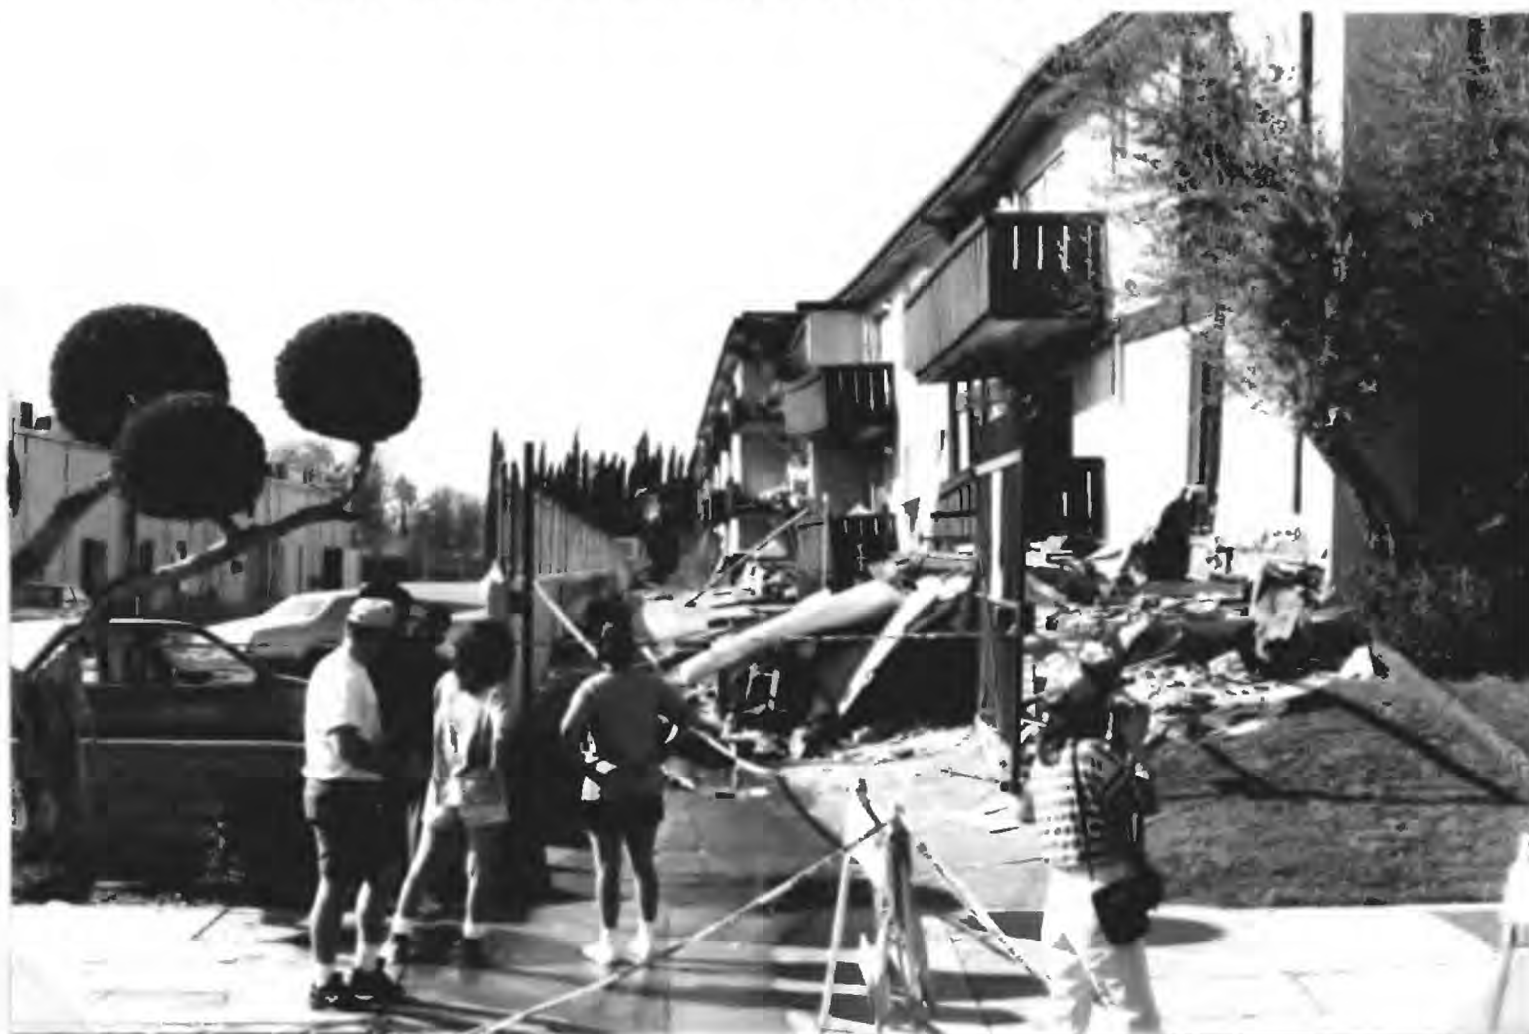
**Figure 7.** Partial collapse of a store building in a shopping center near the Northridge Fashion Mall, (listed under intensity IX).

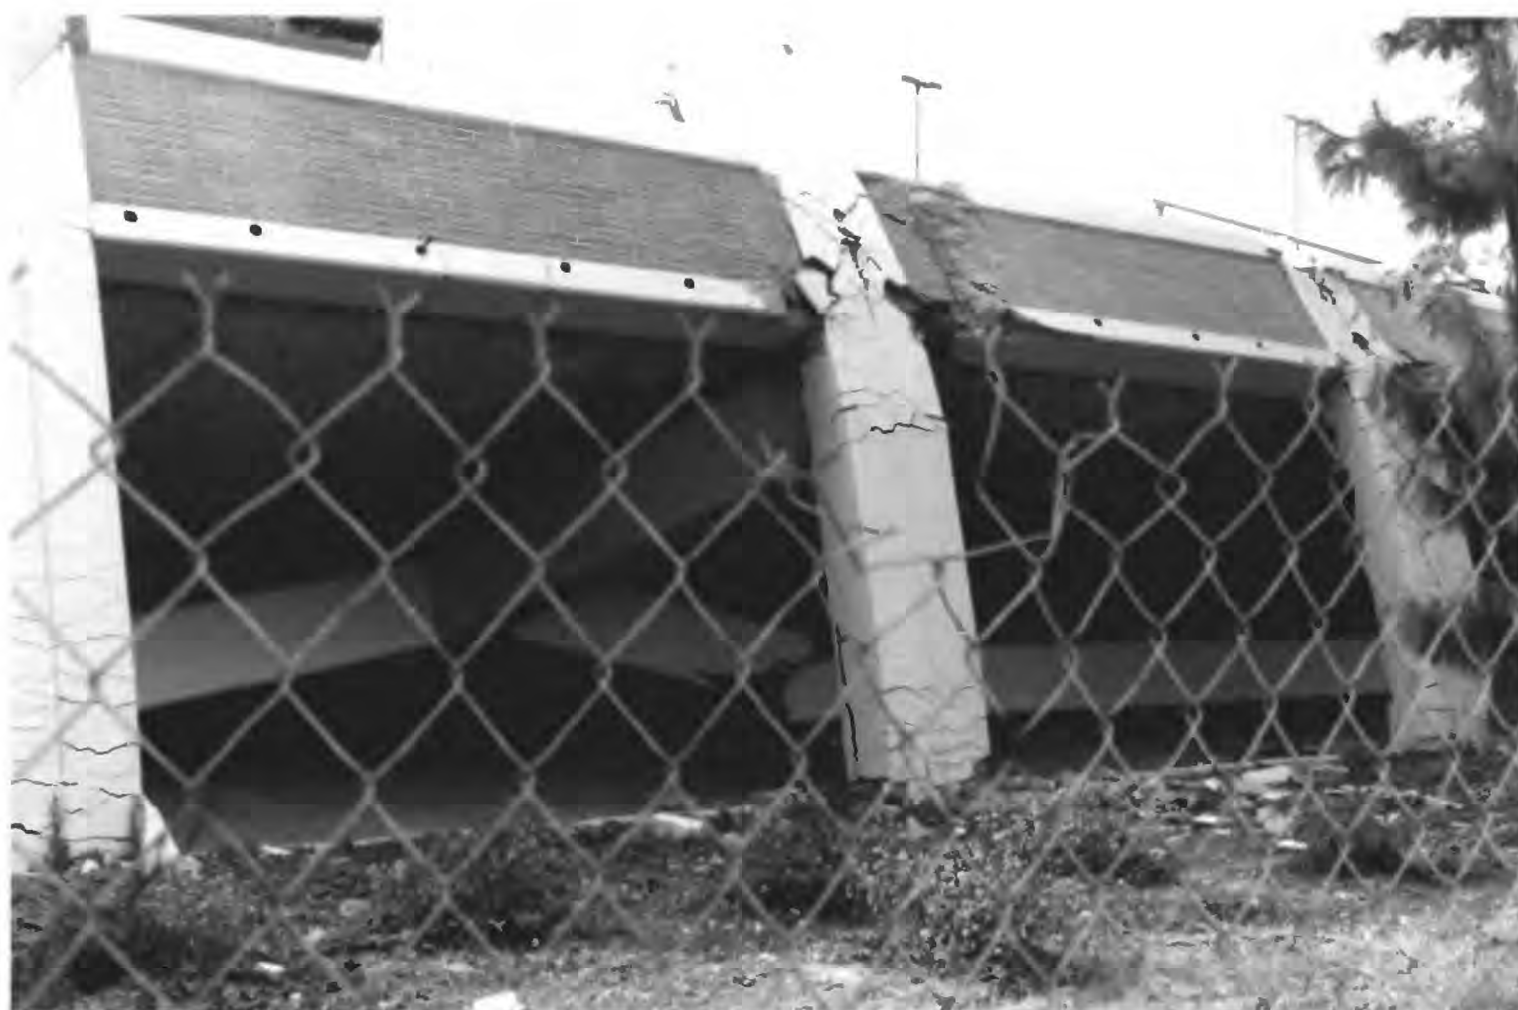
Many multi-unit wood-frame residences were destroyed. Sixteen people were killed in the partial collapse of buildings in the Northridge Meadows Apartment complex (fig. 8): the casualties occurred in apartment units that shared the first-stories with parking areas. This was the worst loss of life associated with failure of any single building complex in the earthquake.

**Figure 8.** Northridge Meadows apartment complex, Northridge( listed under intensity IX). Collapsed building in right foreground was formerly at same height as, and aligned with, uncollapsed building in middle background.

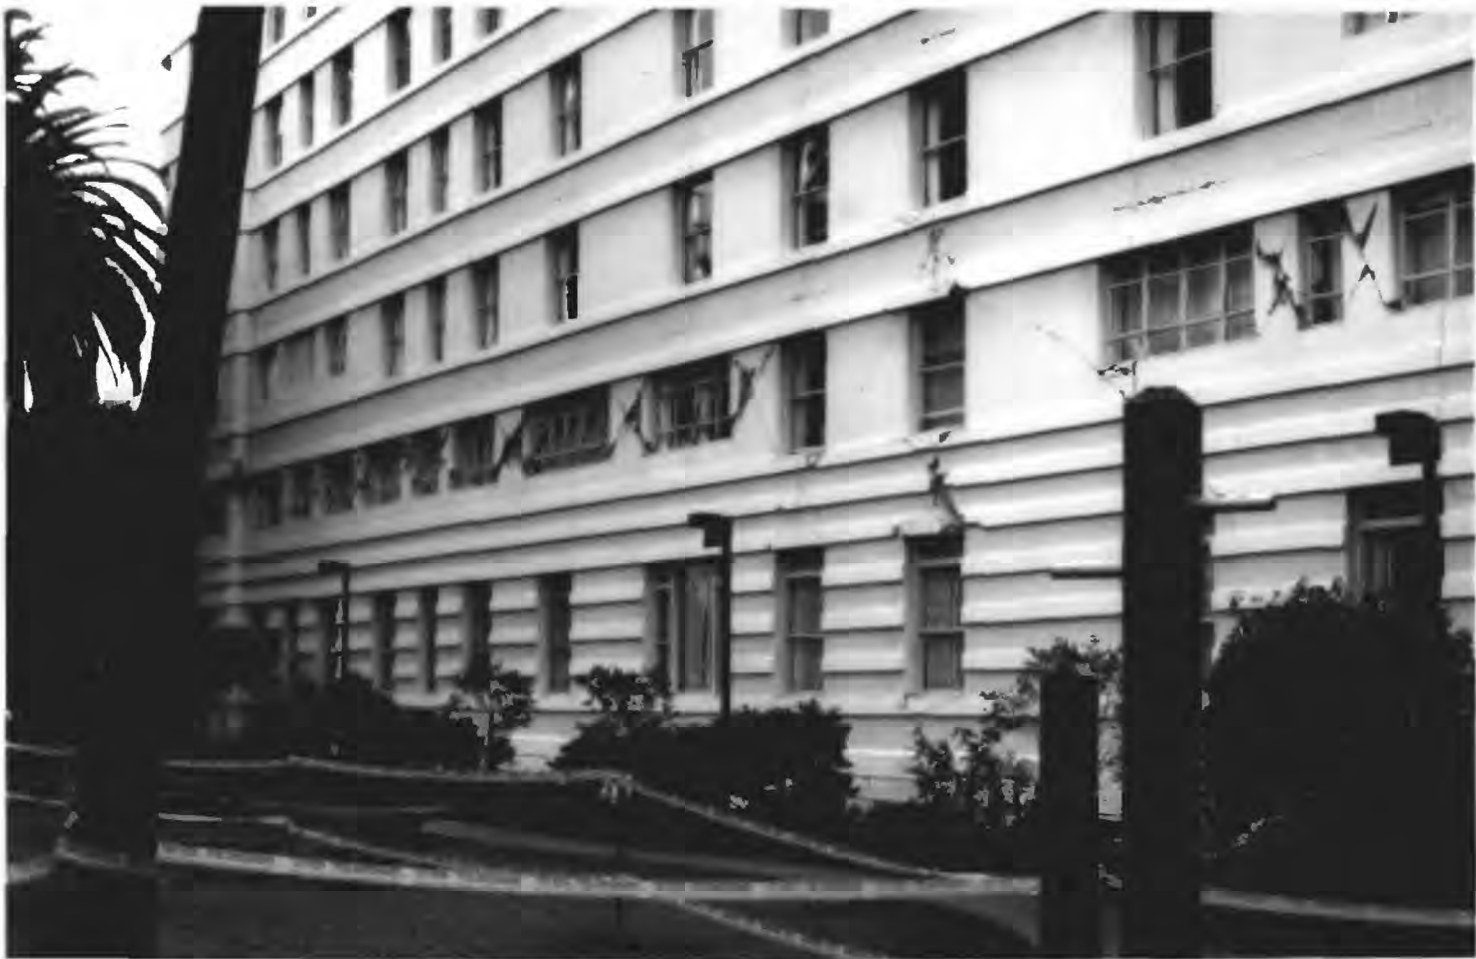
**Figure 9.** Collapsed parking structure at California State University at Northridge (listed under intensity IX).

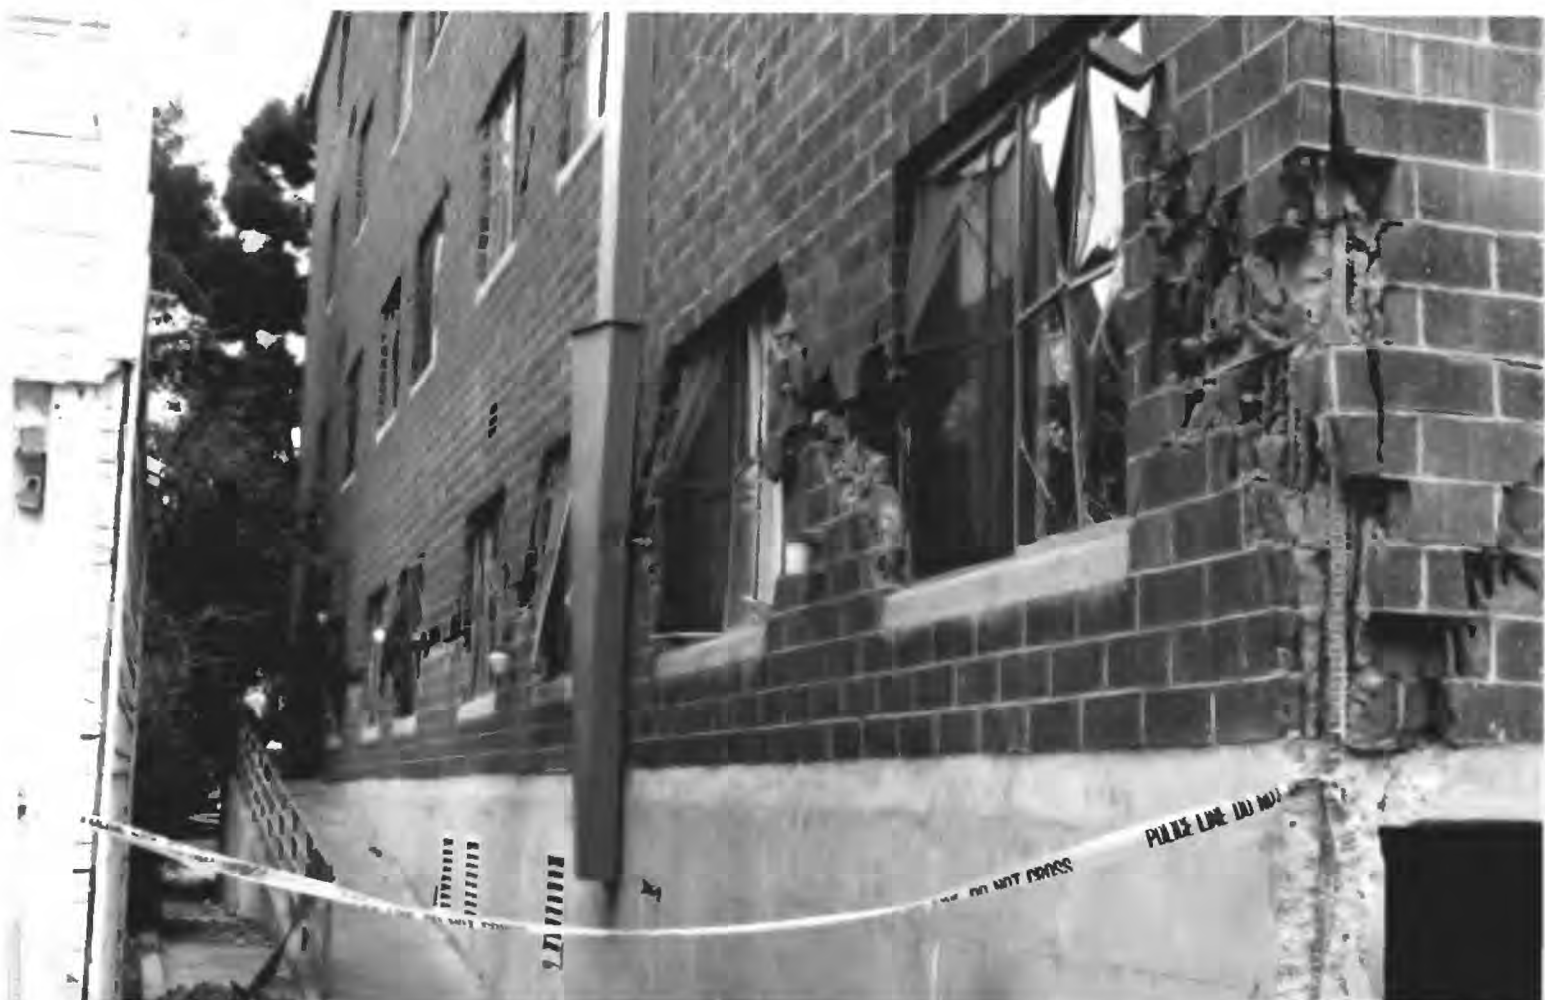
**Figure 10.** St. Johns Hospital, Santa Monica (this part of Santa Monica listed under intensity IX), showing diagonal shear cracks in piers at the second story level.

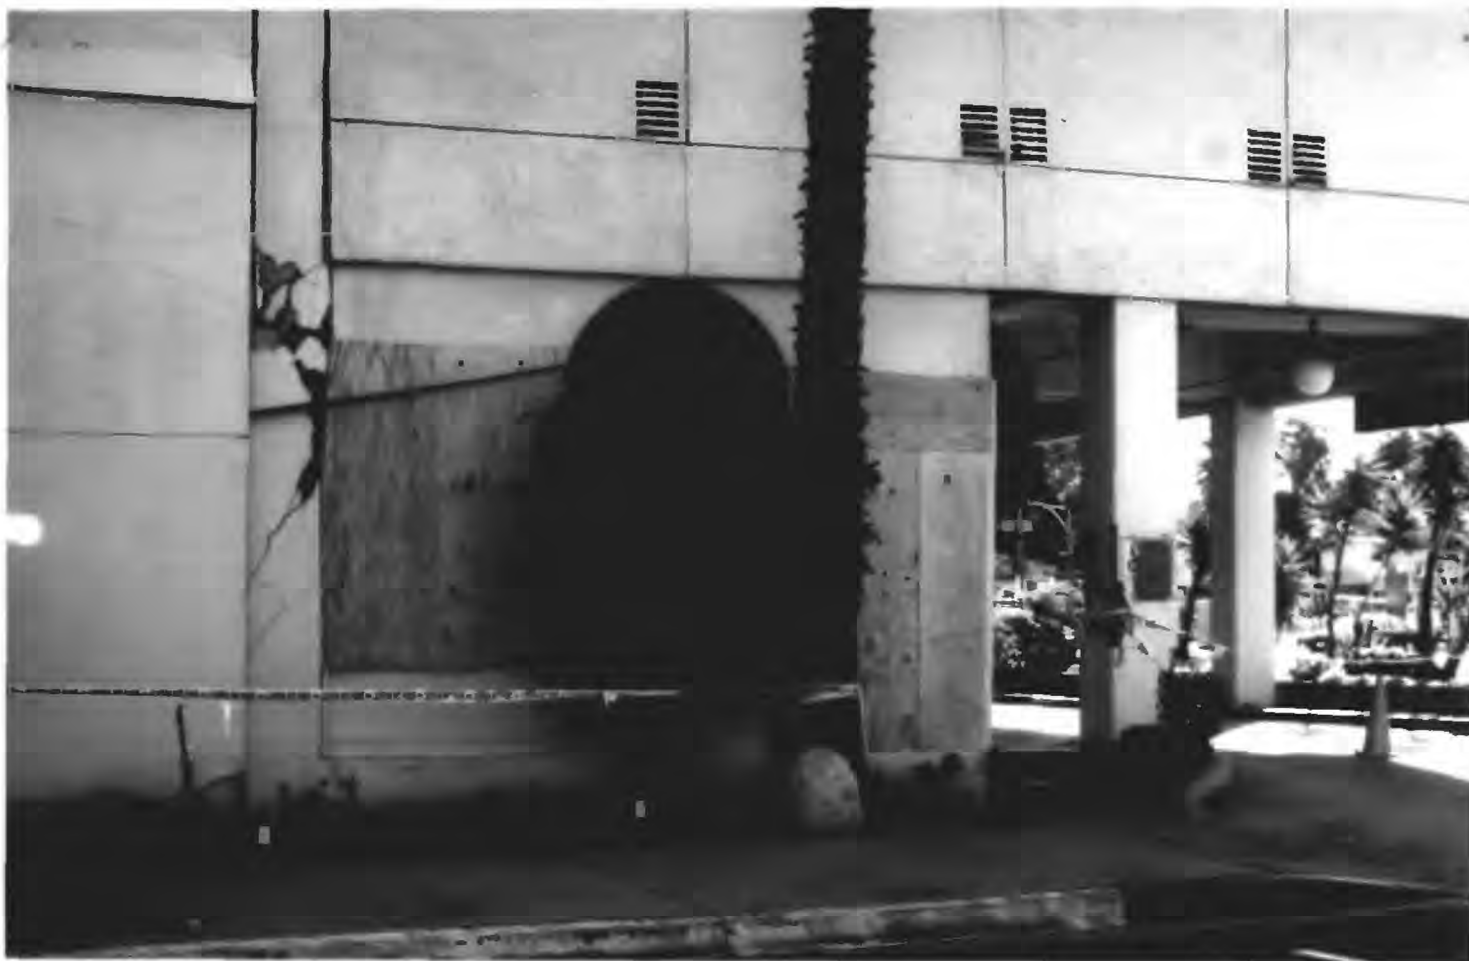
*"A large plate-glass window blew out; the chimney broke at roofline; there was chipped stucco at foundation line, but house structurally in good shape. Outside, three cinder-block property walls fell and a wooden patio covering was damaged. The water heater, housed in an exterior closet, broke loose from strapping, pulling water connections out of couplings. There was massive water loss - had to shut off house supply at street."* Santa Monica (St. Johns Hospital and vicinity). We have assigned intensity IX to this location on the basis of damage to several reinforced concrete and reinforced masonry structures. We have not attempted to define the boundaries of the intensity IX region but rather consider this location to be an intensity IX site within a region generally characterized by intensity VIII. A wing of St. John's hospital, a seven-story, reinforced-concrete structure, sustained diagonal shear cracks in the second story piers and walls (fig. 10) and was closed after the earthquake. The hospital's parking structure was also damaged. The Berkeley East Convalescent Hospital, a five-story reinforced masonry building situated across a street from St. Johns hospital, had cracked piers (fig. 11) and spalled face shells at the ends of wing walls (Hall, 1994).

**Figure 11.** Damage to piers in the northwest-facing wall of the Berkeley East convalescent hospital, Santa Monica (this part of Santa Monica listed under intensity IX).

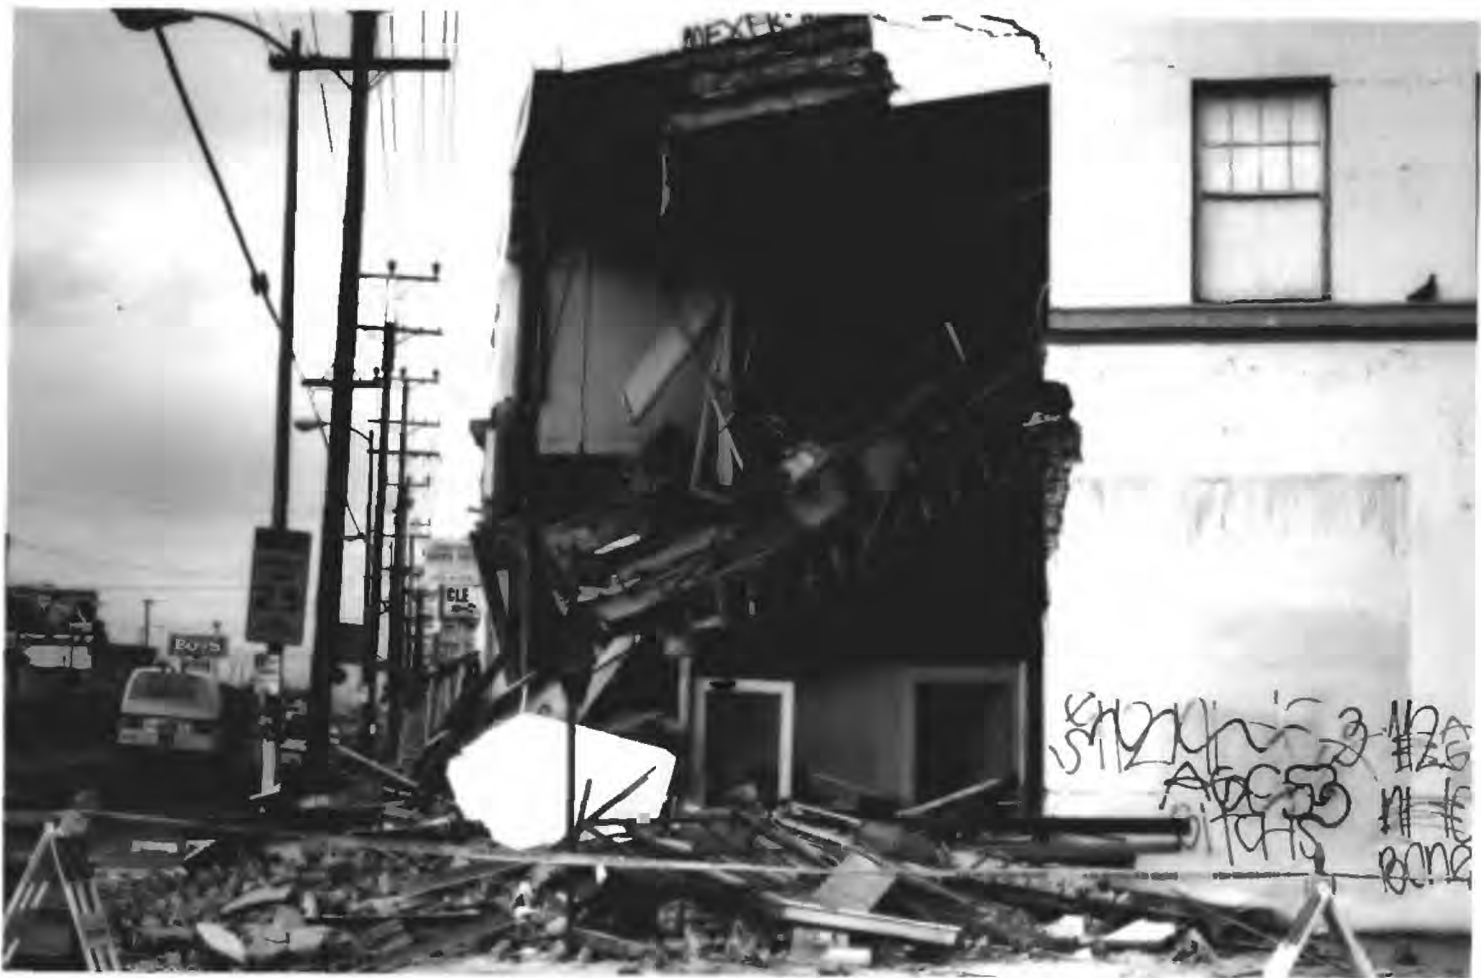
**Figure 16.** Damage to unreinforced masonry building, Hollywood Boulevard, Hollywood (listed under intensity VIII). At the time this picture was taken, most bricks and other debris on the sidewalk had been removed.

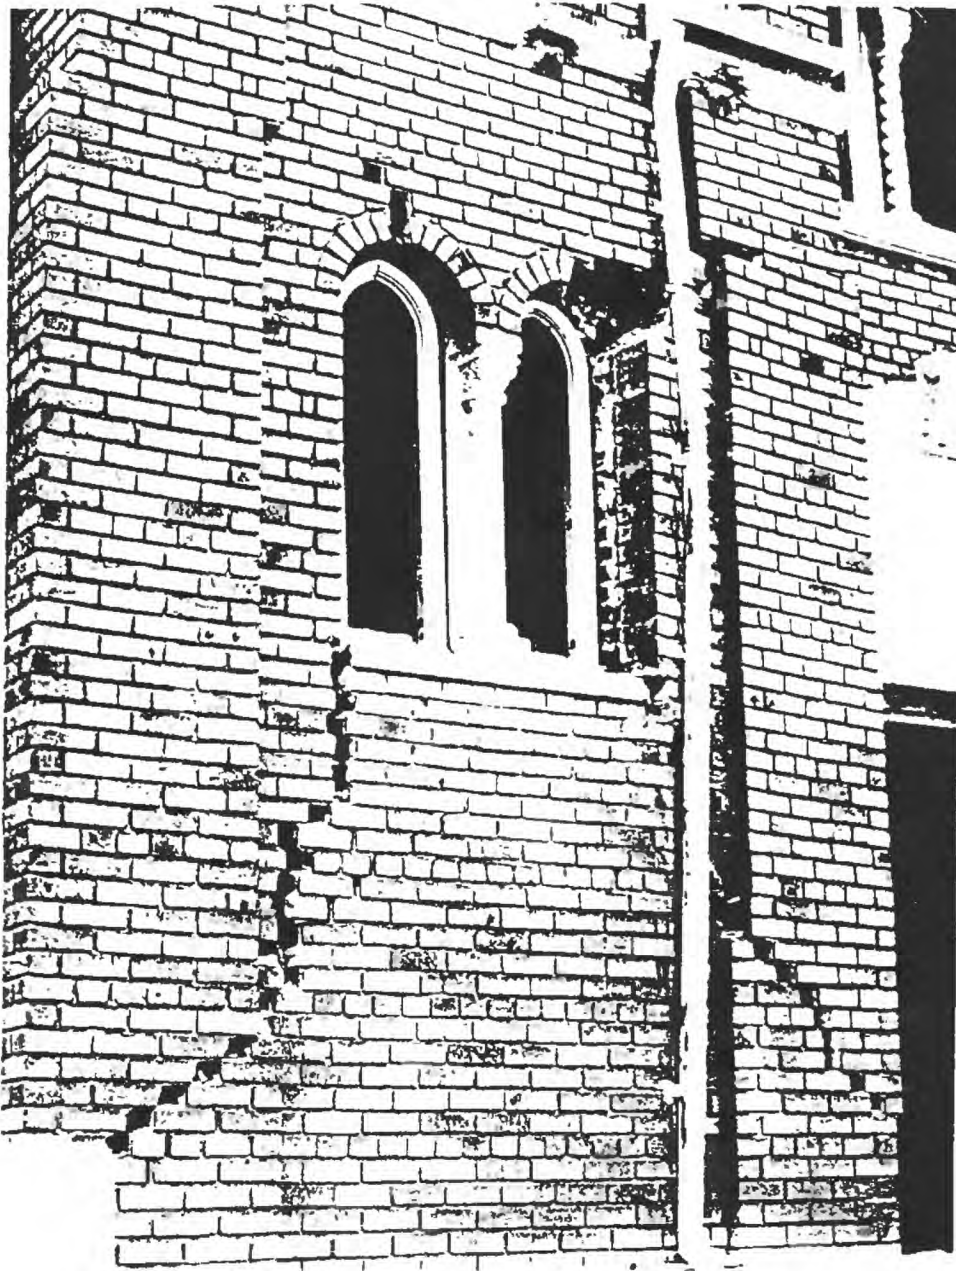
**Figure 17.** Damage to unreinforced masonry building, Los Angeles (West Adams) (listed under Intensity VIII).
